Construction Highlights - June, 2005

On Tuesday, June 7, 2005, the steel contractor, [Hagerman Construction of Indianapolis](#), commenced work on the six-story, 293,000 square foot addition to the historic Central Library.

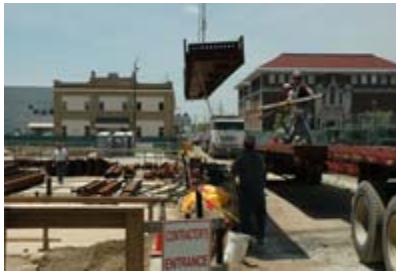
Unloading Steel

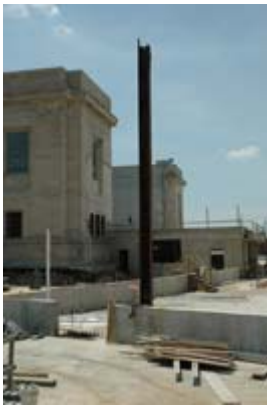
First Column in Place

The first columns of steel were hoisted by the tower crane to marked locations, lowered onto awaiting anchor bolts, and secured. The new structure began to rise shortly after noon and within forty-eight hours the first sequence was well underway. The process of erecting steel consists of setting six (6) sequences of steel beginning on the east side (Pennsylvania Street) across the building footprint to the west side (Meridian Street) of the construction site.

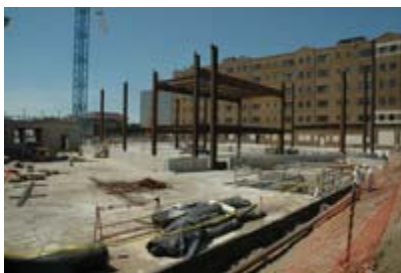
Each sequence represents two "floor" levels spanning across two bays. A combination of columns, beams and purlins are used as the main frame

Columns, Beams, and Purlins

of the structure. Columns stand vertically and act as supporting pillars. Beams run horizontally and connect the columns. To support the metal decking, purlins are attached perpendicular to the beams that connect the columns.

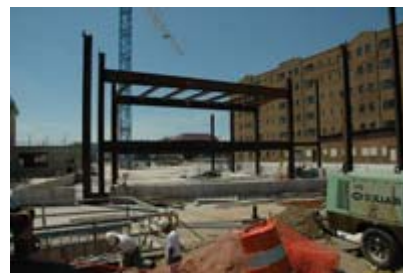
Purlins

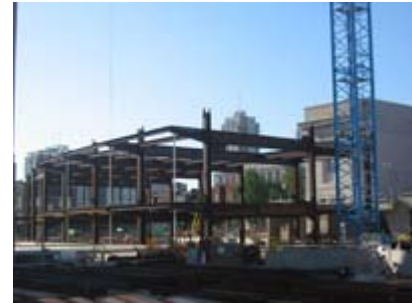
Steel Sequence

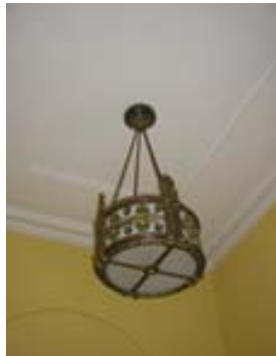
Reconstructed Chandelier

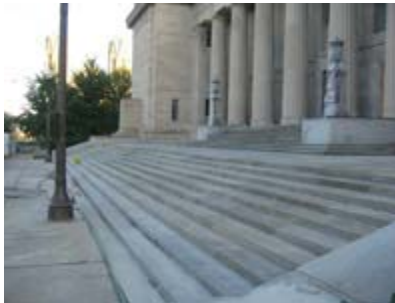
South Entrance Steps

The reconstruction of the substructure under the building's south entrance, including a new snow melt system, and replacement of the original granite steps nears completion.
